# Manhole Inspection Summary

Manhole # S06GG2001MH

**Location** Address: **7038 WALLIS AVE**

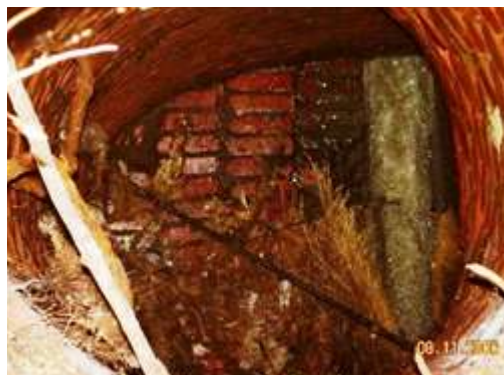
Top View

Barrel, Bench and Channel root intrusion.  
Evidence of surcharge - Bench debris.  
Corroded steps.

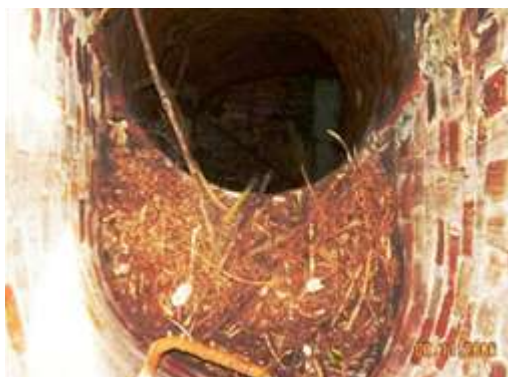
Corbel - Barrel offset

Adjustment root intrusion and infiltration.  
Corroded steps.

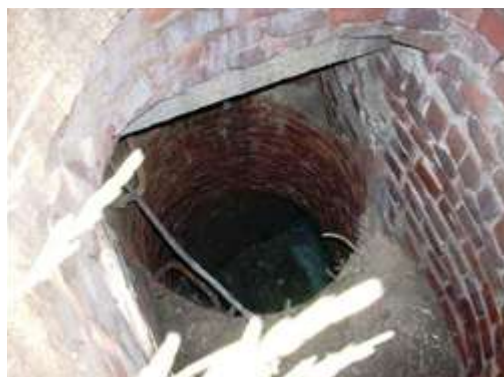
Defect

Adjustment, Corbel, and Barrel infiltration.

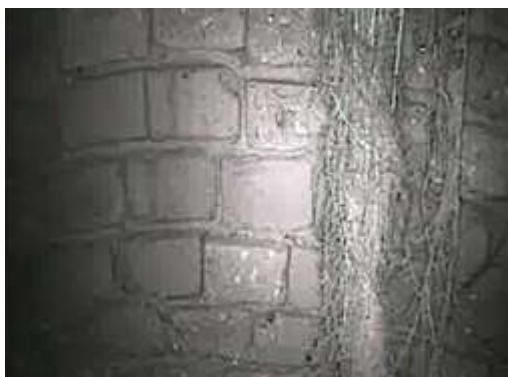
Defect

Barrel root intrusion and infiltration.

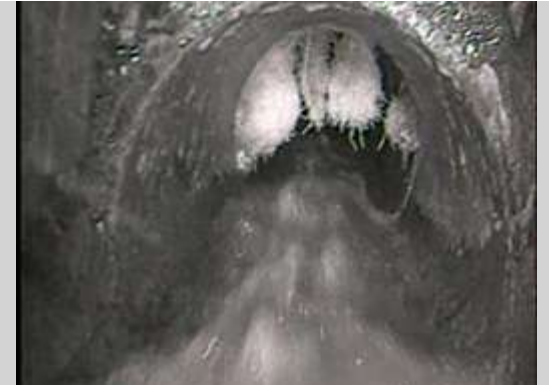
### 12 in. Circular Gravity Sewer Pipe Out @ 12 O'Clock

Comments **The O12 pipe picture shows root intrusion inside of the pipe. The I6 pipe picture shows Barrel, Bench, and Channel root intrusion.**

Infiltration: **Evidence** Pipe Seal Cond: **Unknown**

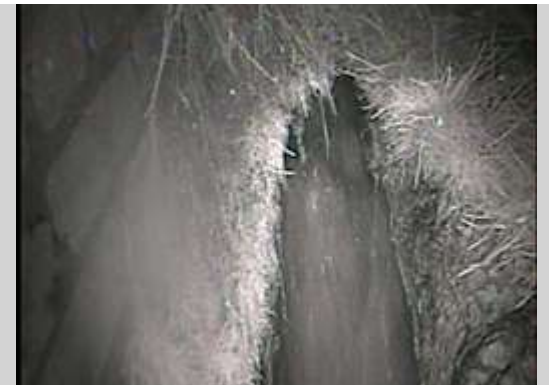
### 10 in. Circular Gravity Sewer Pipe In @ 6 O'Clock

Infiltration: **Evidence** Pipe Seal Cond: **Roots**
